GUAM ENVIRONMENTAL PROTECTION AGENCY • *AHENSIAŇ PRUTEKSIÓN LINA'LA' GUÅHAN*

July 23, 2021

SUBJECT: Site Inspections at Samsung Mangilao Solar Project Site, July 23 and 18, 2021

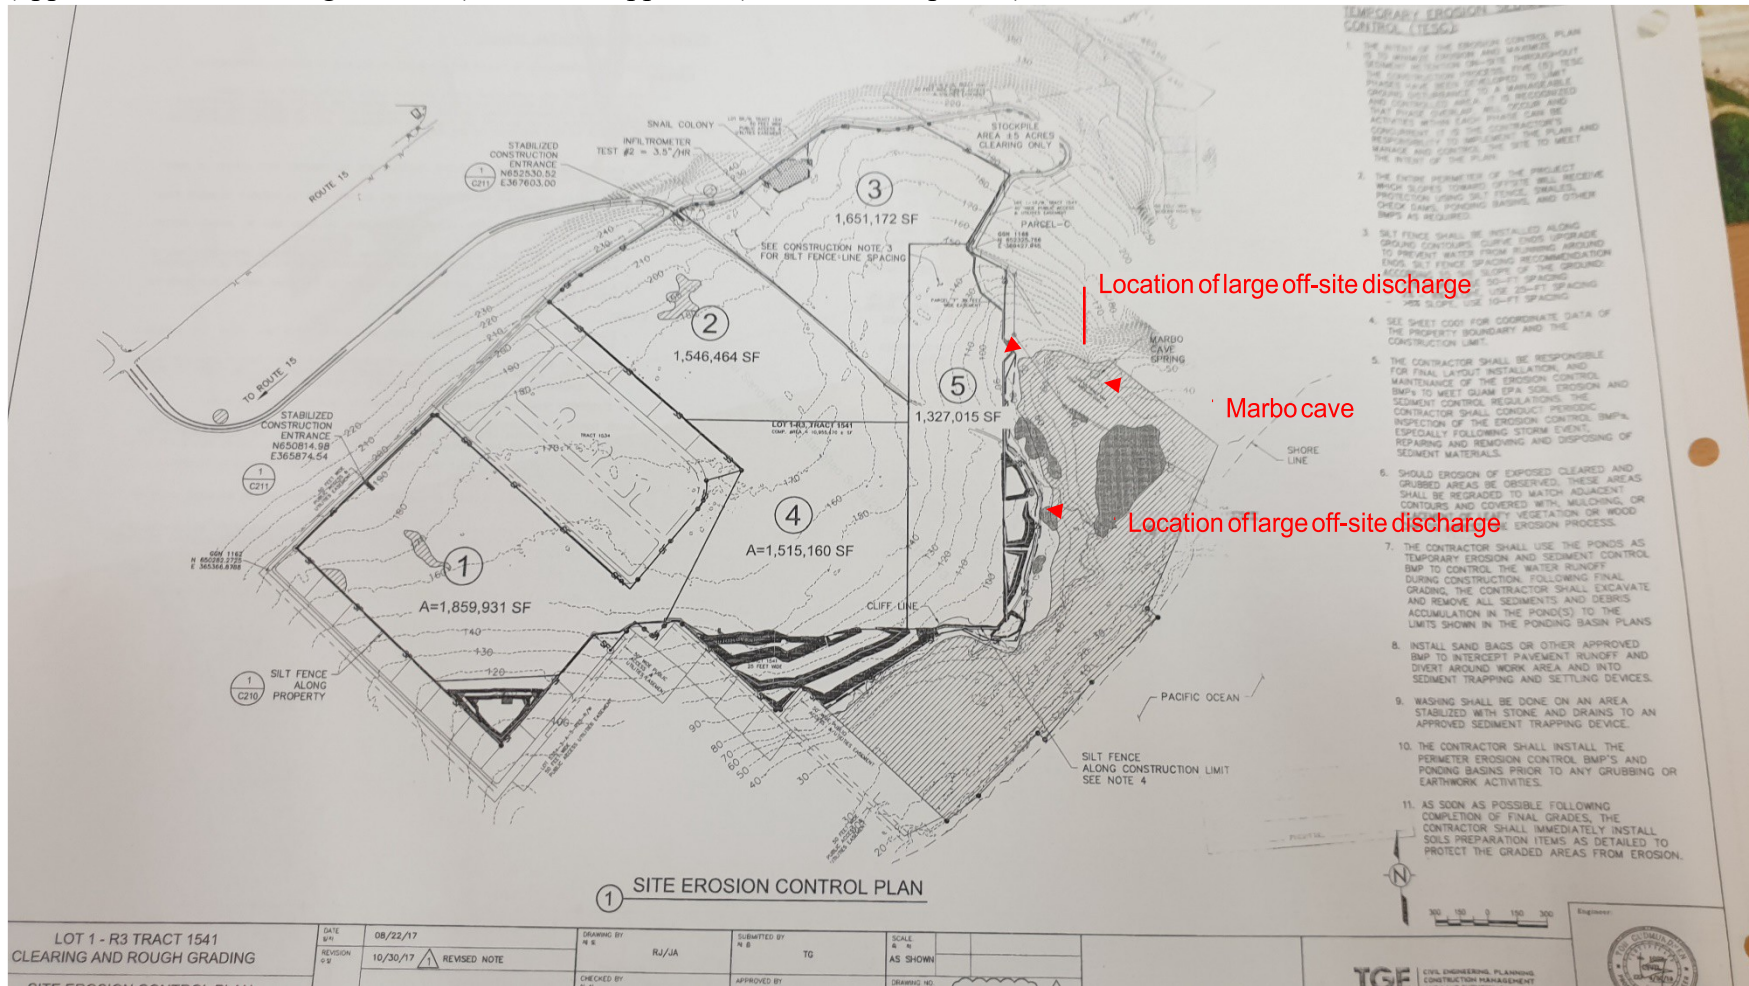
Overall site plan, but note that the designs of Pond 3 (center bottom) and Pond 4 (right bottom) were changed, and a Pond 5 was added (upper annotated discharge location) w/ GEPA approval (see additional photos)

Annotations in red added to highlight location of discharges toward Marbo Cave (upper) and from Pond 4 area (lower), which was the subject of the complaint.

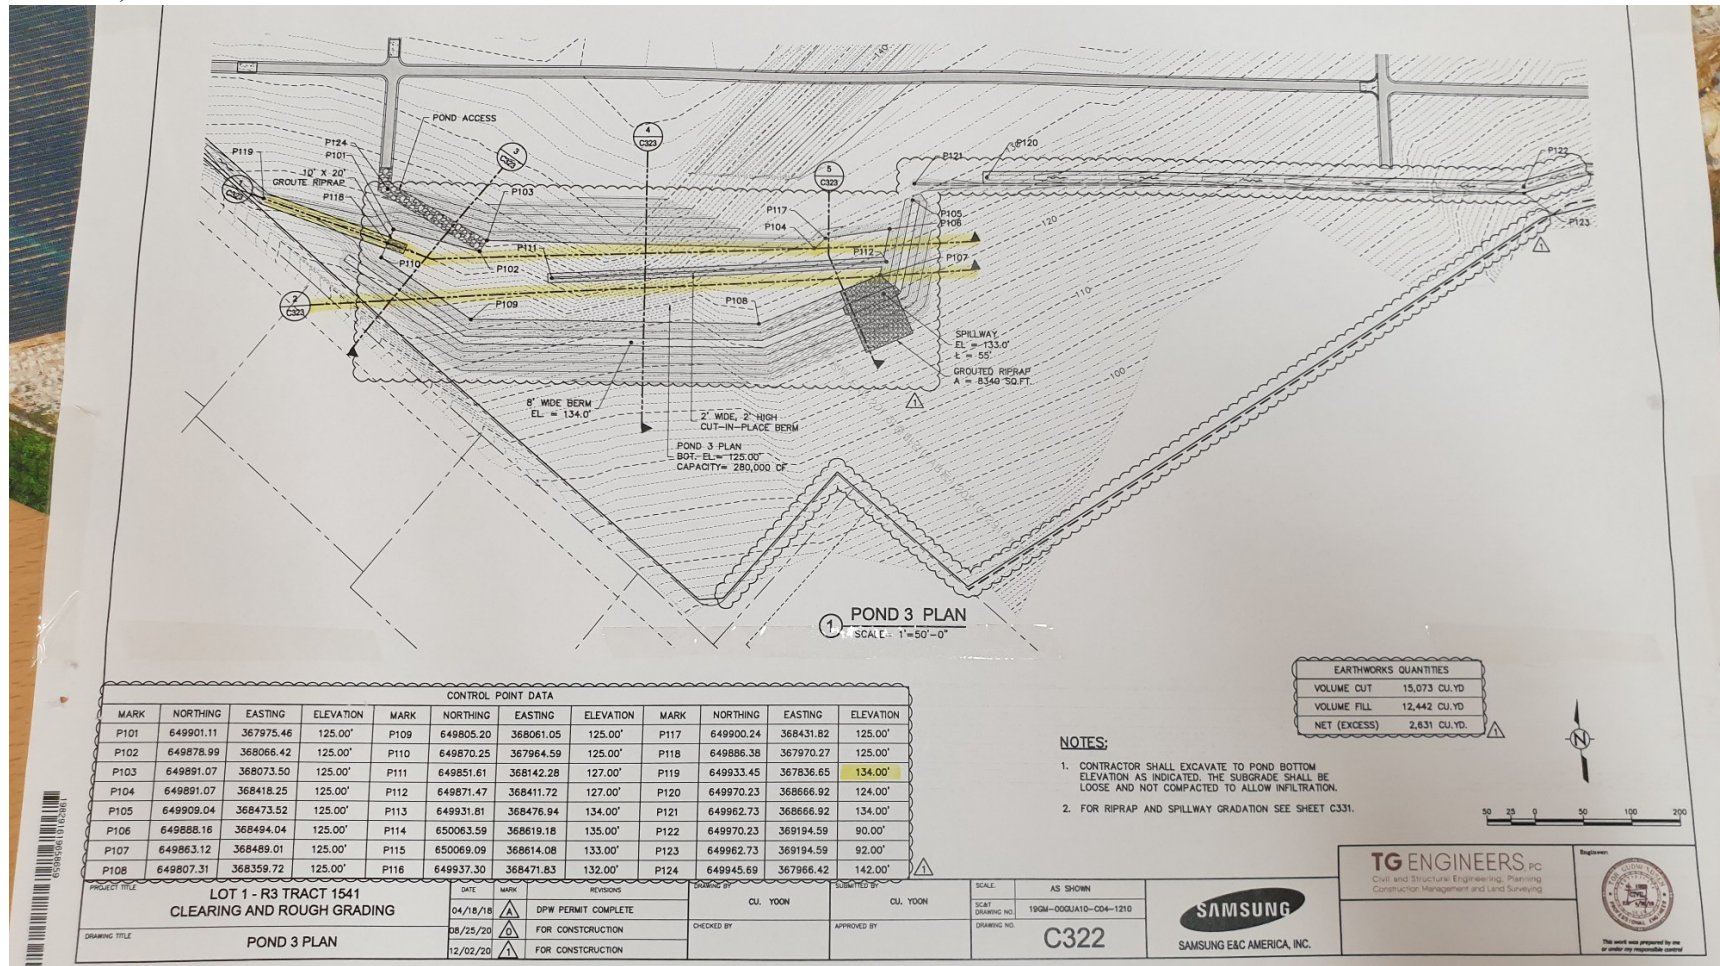
Revised Pond 3 plan, as approved by GEPA July 2020. Note stone riprap at overflow. Per Samsung, this had not yet been installed. (July 23, 2021)

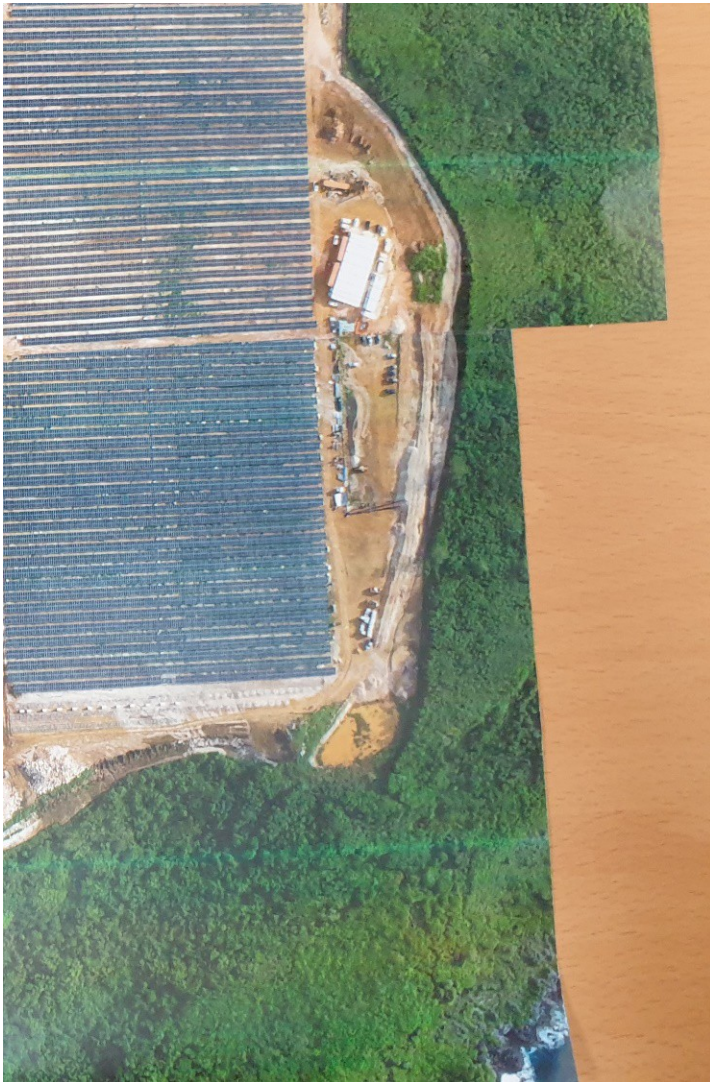
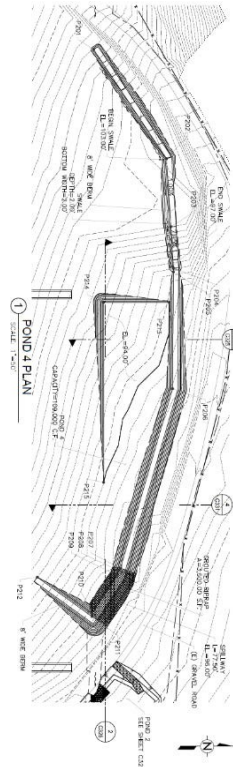
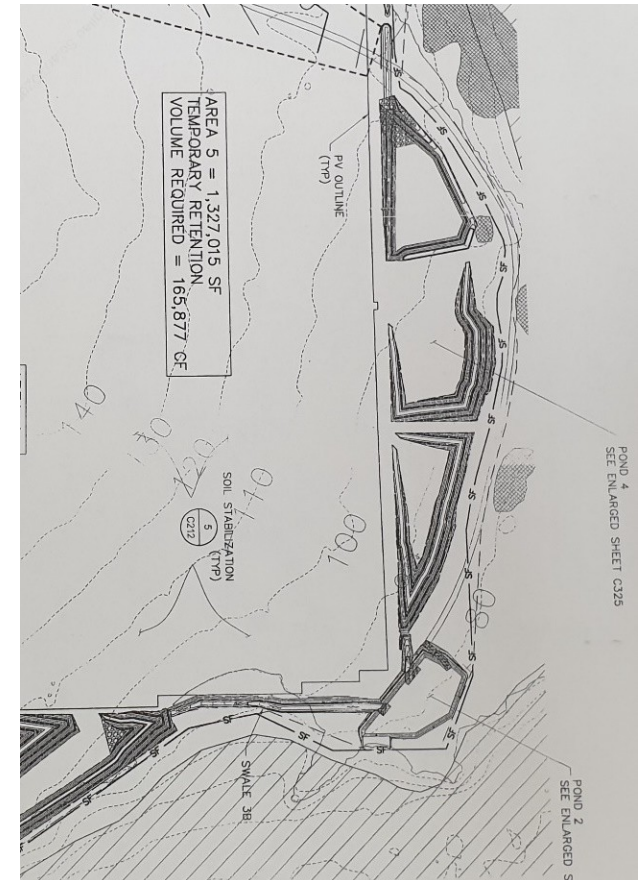
From the aerial images I noted that the location of Pond 4 appeared to coincide with the location of the project offices. Mr. Kim and staff confirmed that Pond 4 had not been constructed yet, and that the project offices were indeed located in the same spot. I also noted that construction of Ponds 1 and 3 appeared to still be underway. This was also confirmed by Mr. Kim and others that were present.

Site aerial image taken July 22, compared to approved E&SC plans (revised plan approved July 2020 in center), showing location of office at Pond 4 site (July 23, 2021)

- I strongly recommended that Samsung begin construction of Pond 4, at the very least the lower sections of the pond where the office is not located, to prevent further discharge.

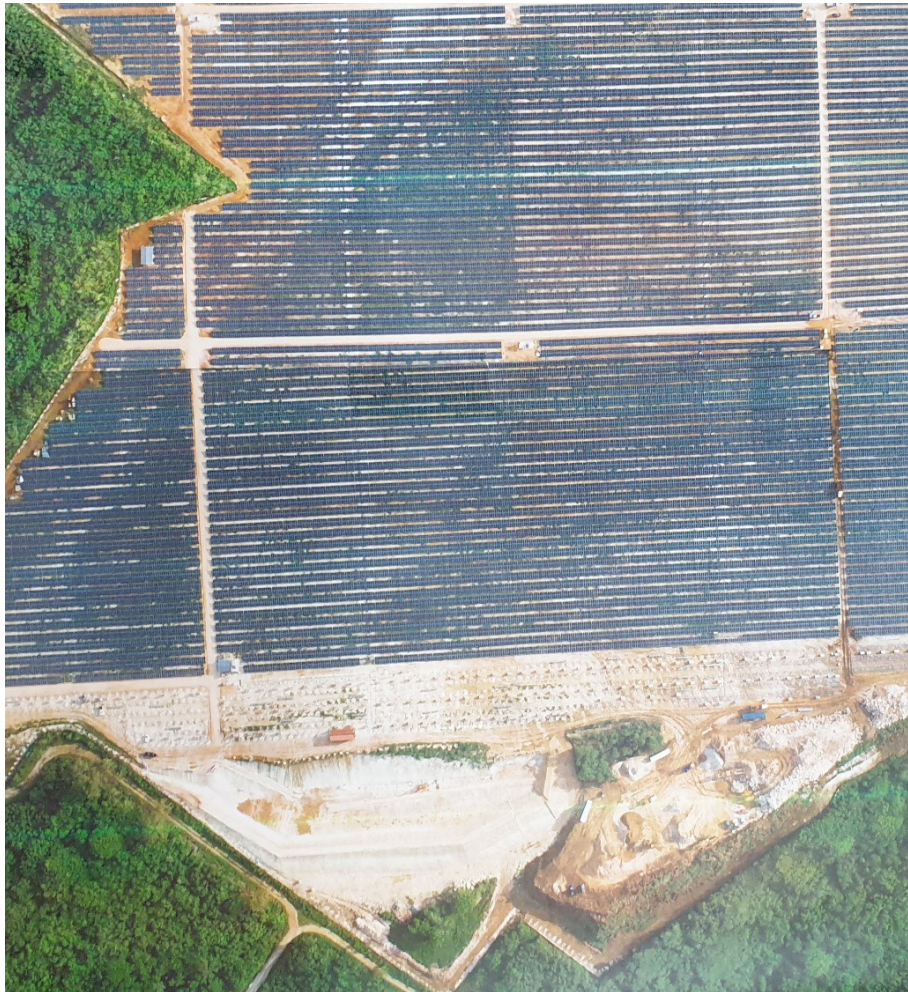
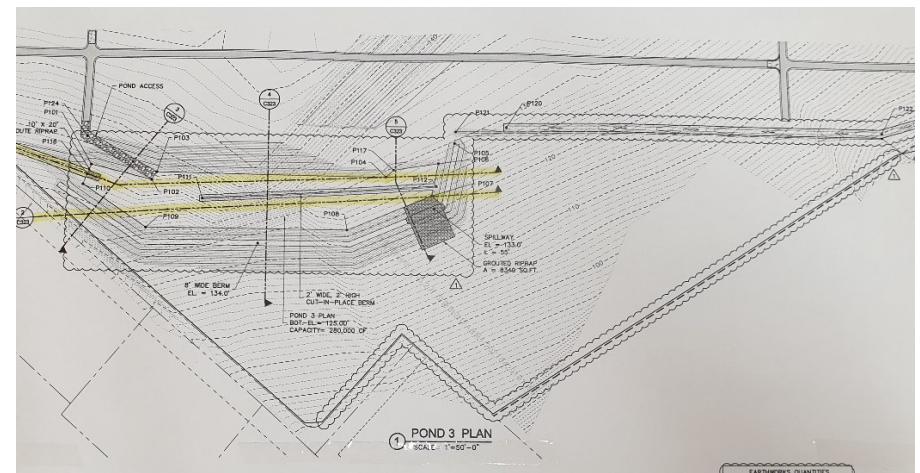
Aerial photo dated July 22, 2021 at location of Pond compared to approved E&SC plan (July 23, 2021)

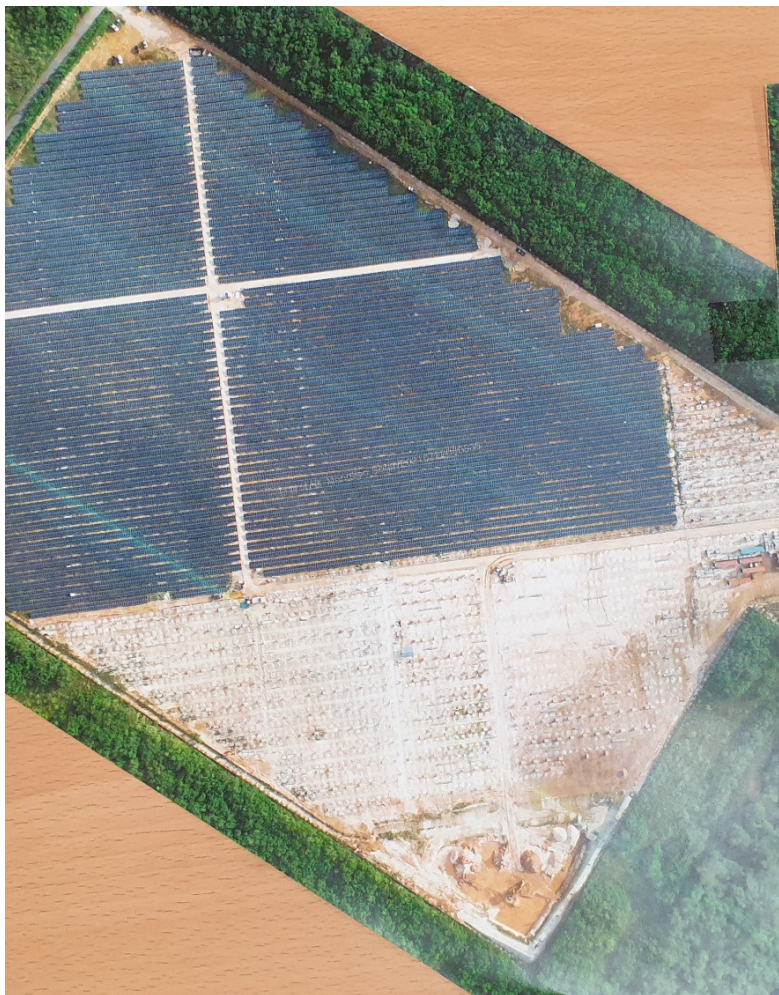
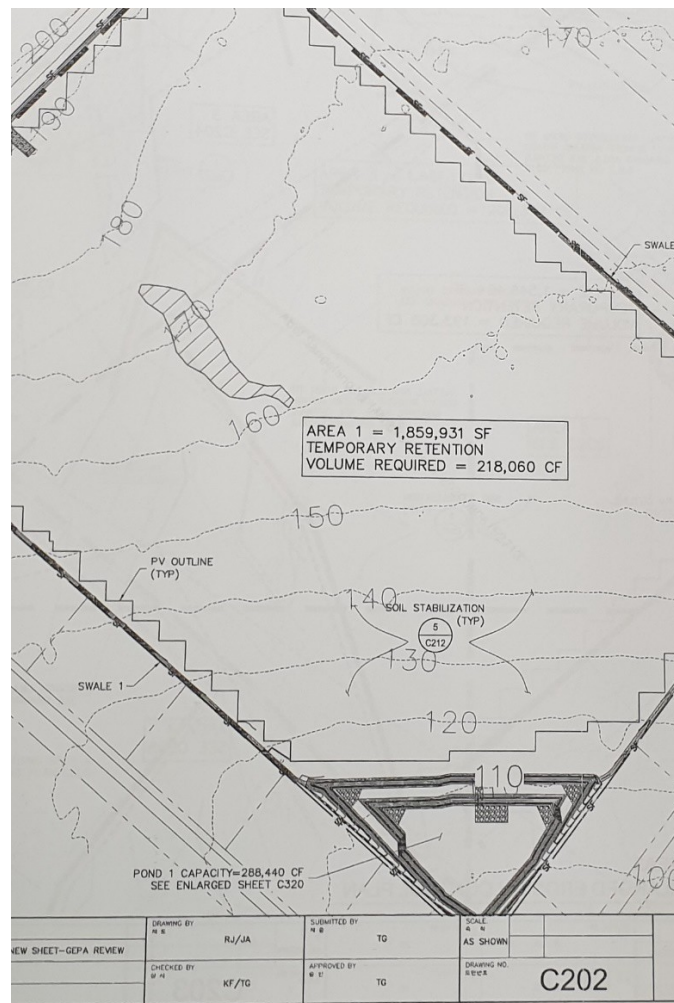
Site aerial image of Pond 1 area, taken July 22, 2021, compared to approved E&SC plan: (July 23, 2021)

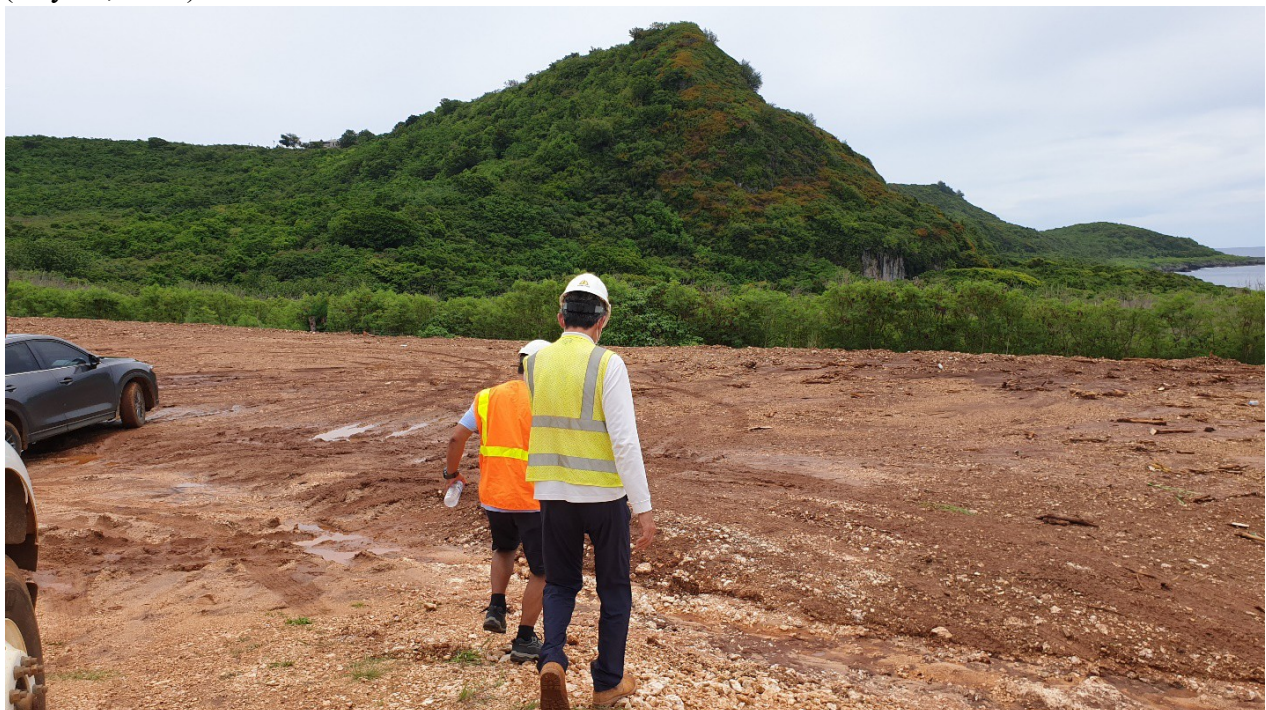
View looking from site office to area where start of Pond 4 berm and swale should be located.
(July 23, 2021)

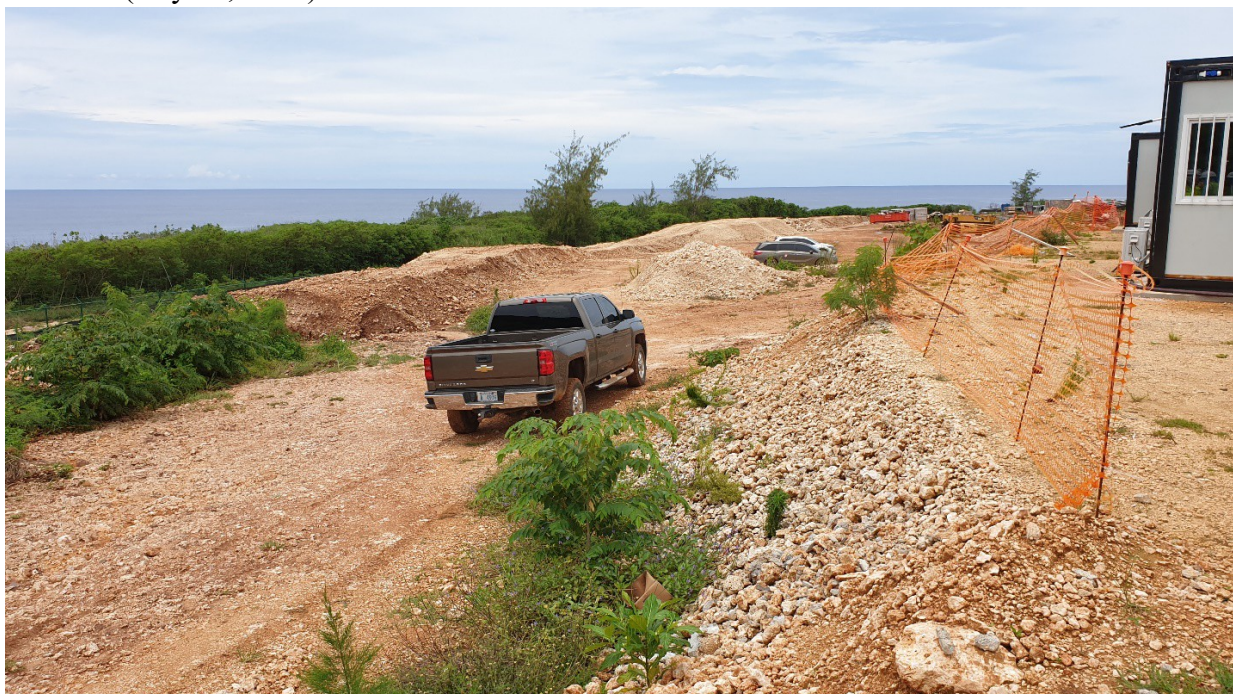
View looking downslope where Pond 4 berm construction has begun, and toward Pond 2 in distance. (July 23, 2021)

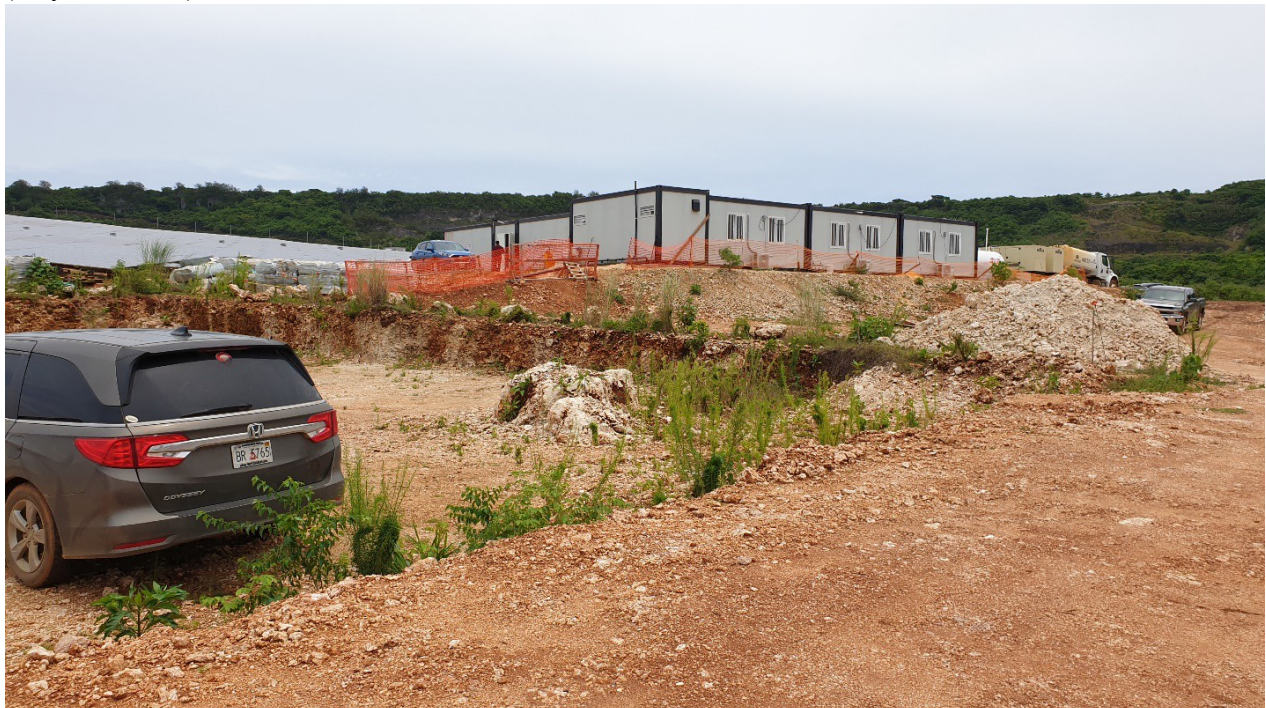
Looking back upslope toward Project Site Office, showing start of (revised) Pond 4 excavation (July 23, 2021)

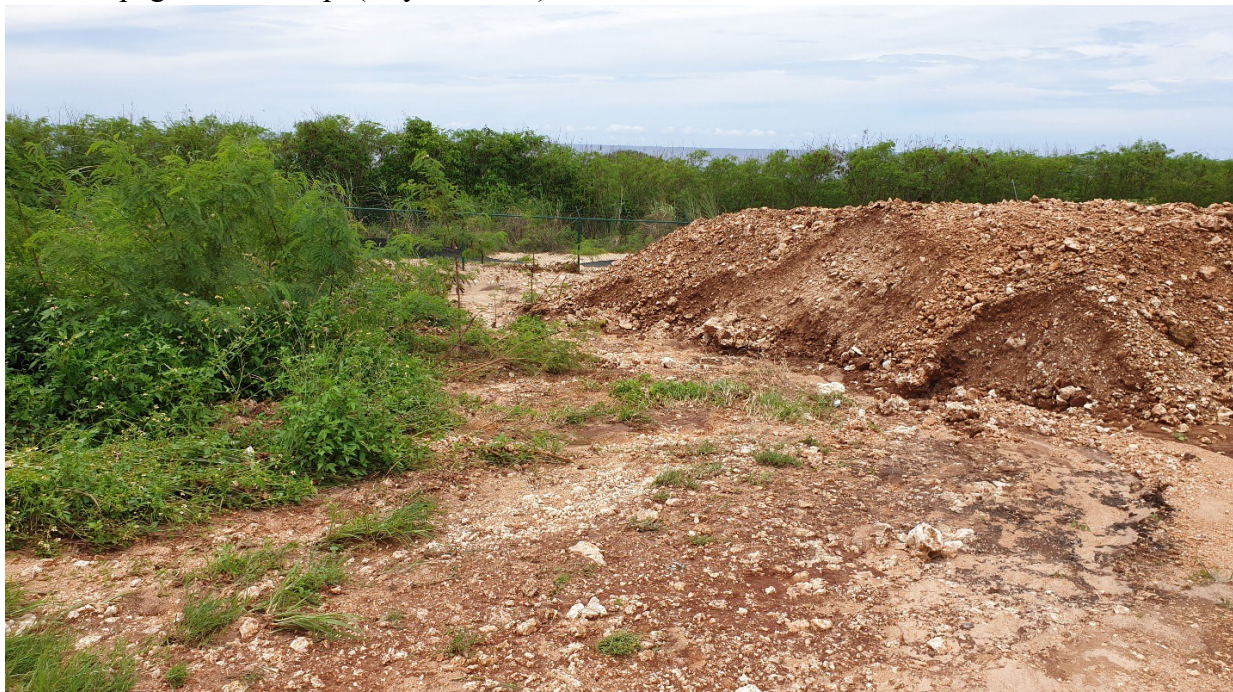
Location of discharge from Pond 4 area to off-site. This is reportedly the location of the complaint. See next page for close up. (July 23, 2021)

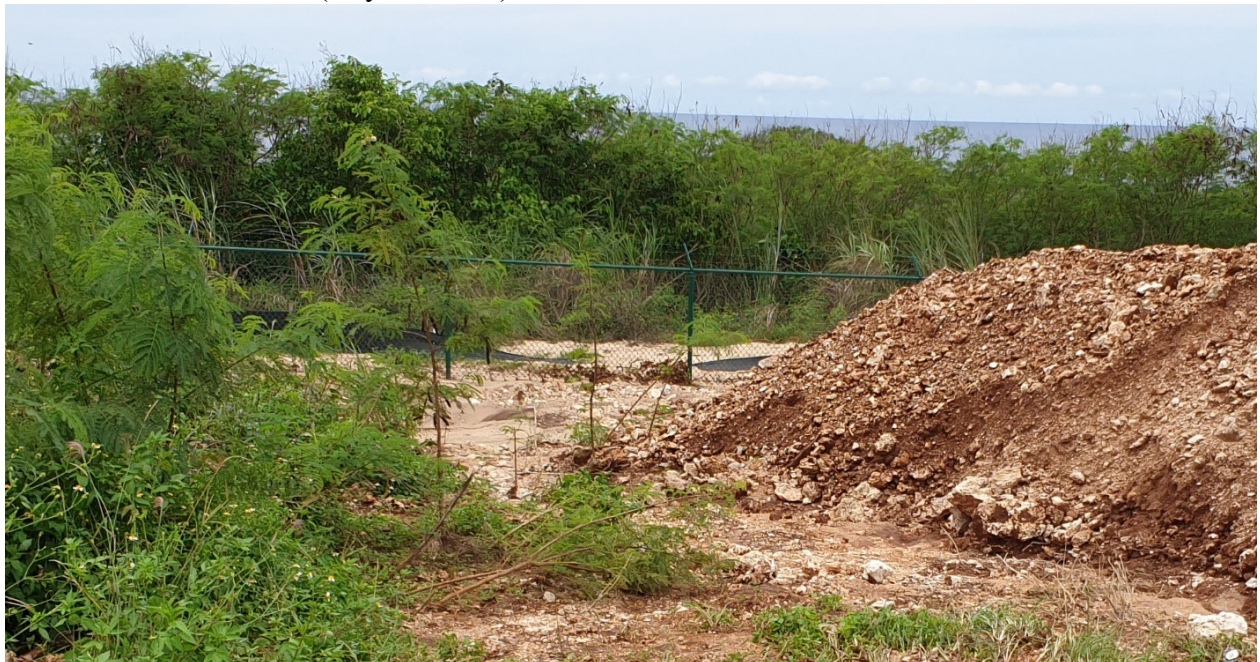
Close up of Pond 4 discharge location. Note accumulated sediment in delta-pattern, and overwhelmed silt fence. (July 23, 2021)

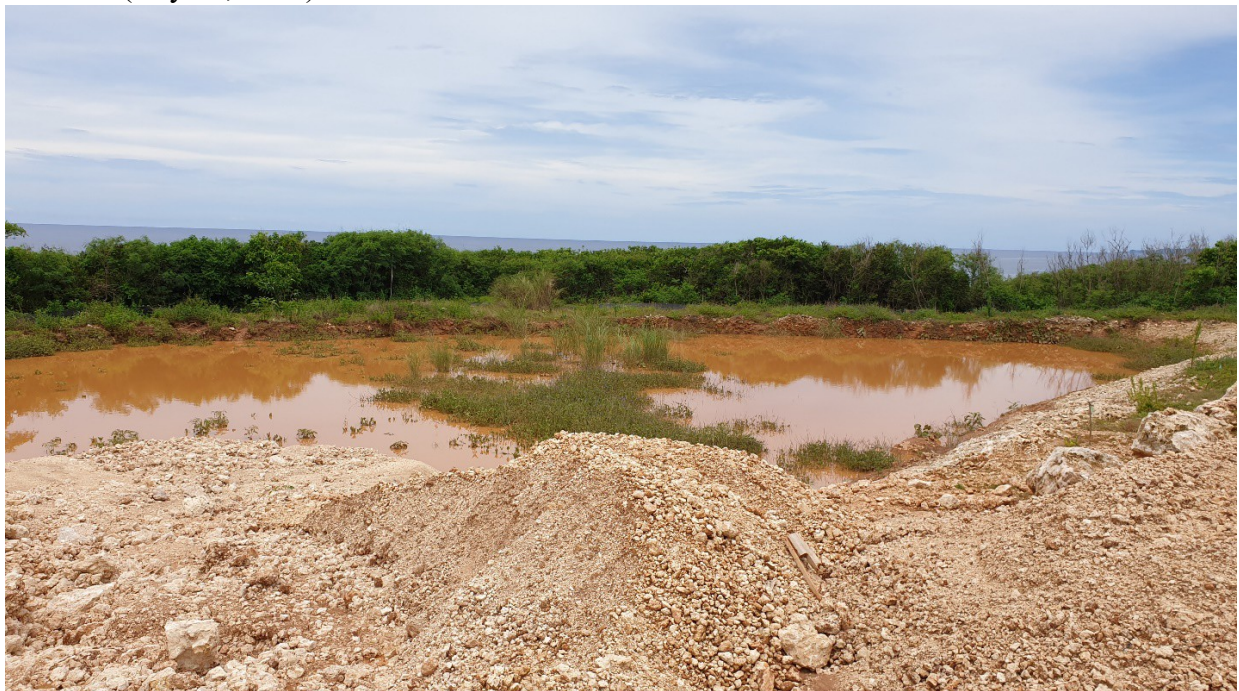
Pond 2, with accumulated runoff and sediment from storm. This pond does not appear to be finished. (July 23, 2021)

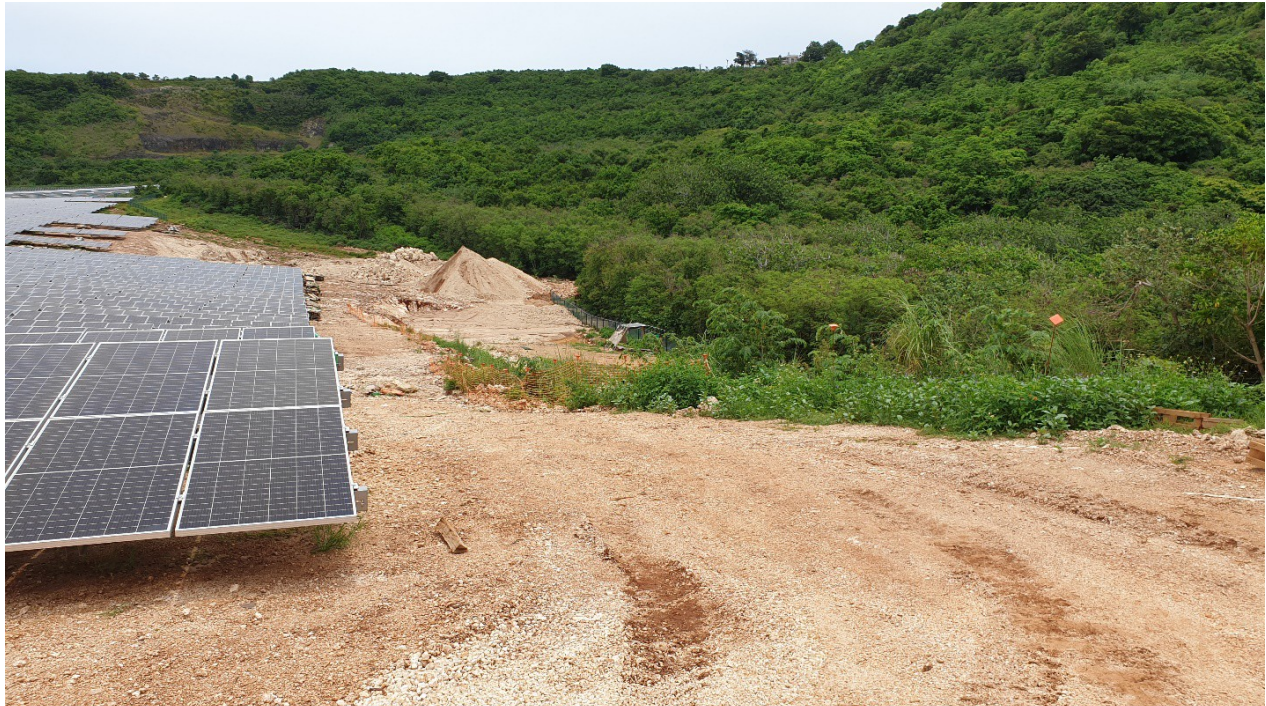
Location of apparent discharge toward Marbo Cave. See next photo for close-up. (July 23, 2021)

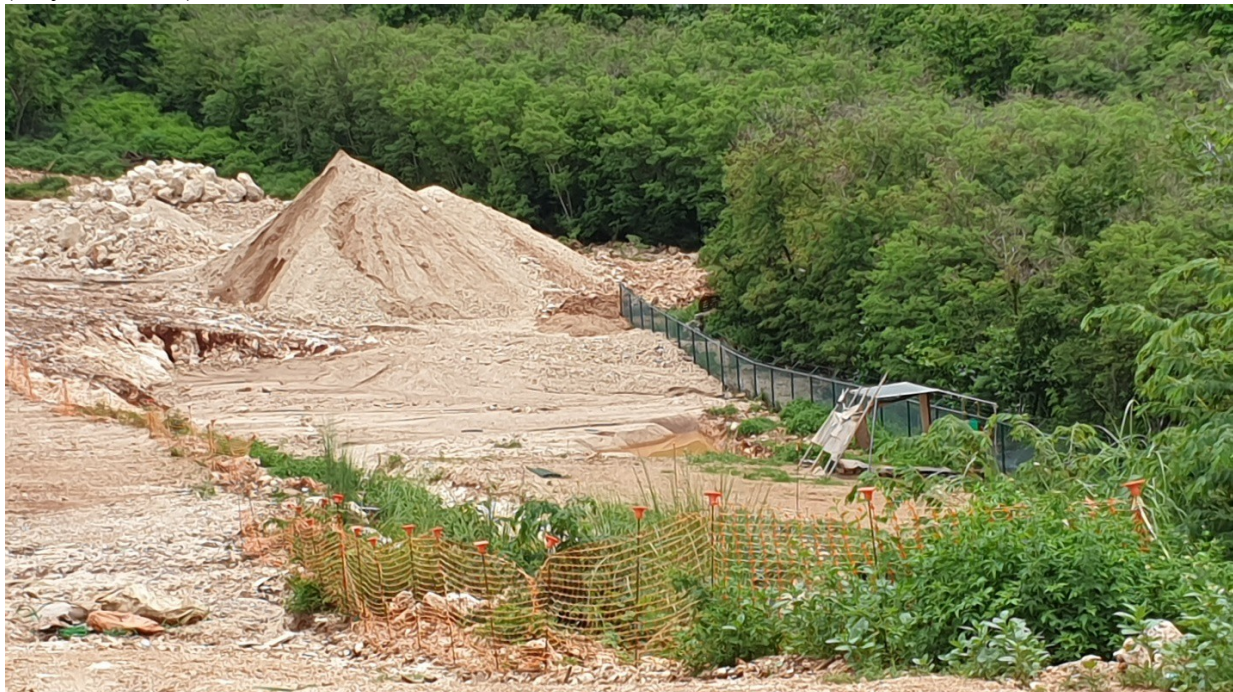
We then drove through the project site to visit Ponds 1 and 3. On the way I stopped and took pictures of an area where evidence of a large discharge of runoff was present. This area does not appear to be served by a sedimentation basin (pond) in the approved E&SC plans, and is directly upstream of Marbo Cave according to the site plans. On the way between Ponds 3 and 1, I observed that the perimeter swale had a large number of ironwood saplings growing in it, as well as a lot of sediment that was obstructing the cross section of the swale. (See addendum below – Pond 5 was added to the site E&SC plans and approved by GEPA on January 4, 2021. I inspected with Johnny Abedania on July 28, 2021 to further investigate).

Close-up of area that appears to be a large, unprotected off-site discharge toward Marbo Cave area. Note large delta-type formation of sediments, indicating long-term history of discharge. (July 23, 2021)

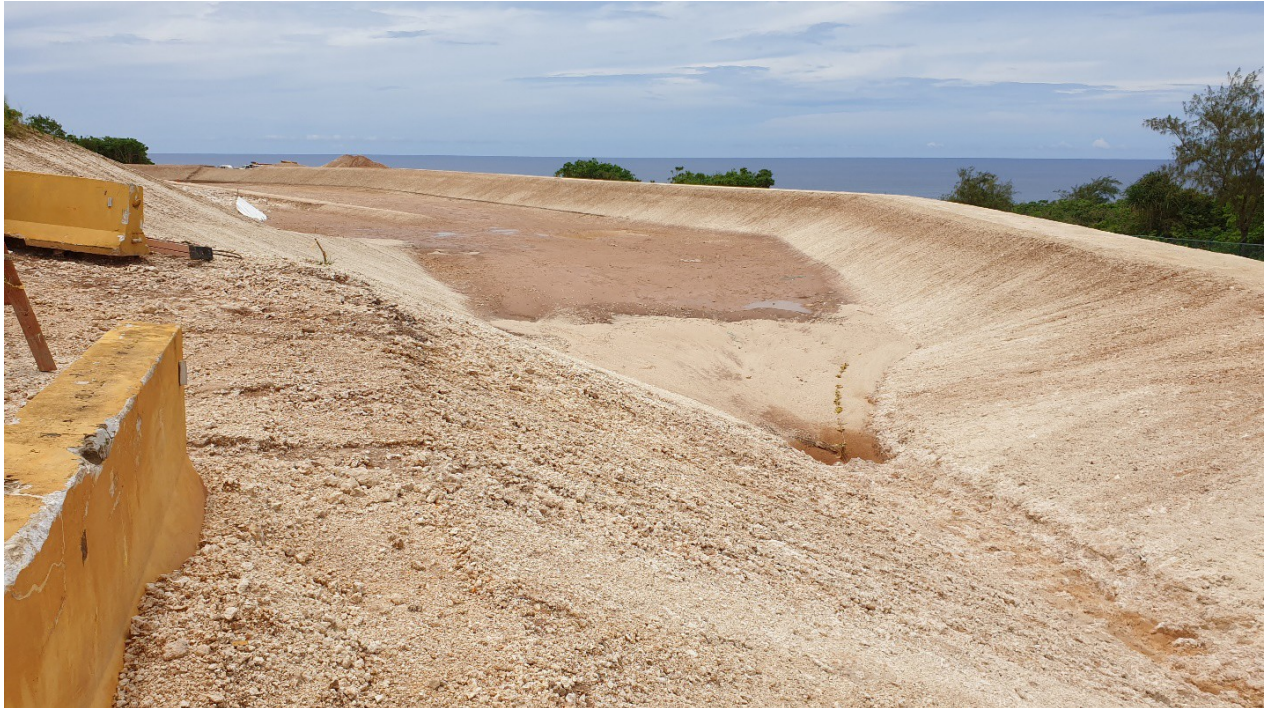
Pond 3 was mostly in place but according to Mr. Kim it was not yet finished; the stone overflow structure still needed to be built. We observed that runoff had only filled Pond 3 about a foot or two. Pond 1 was complete, according to Mr. Kim. We observed that runoff had filled Pond 3 almost to the point of overflowing, by evidence of a clearly visible high water mark. However Mr. Kim stated that it had not overflowed. We observed that there were several stockpiles of material in Pond 1 that served to reduce its capacity to hold runoff. We also observed that a large amount of sediment had accumulated in Pond 3, and discussed the need for maintenance to remove it periodically, and completely once the site was stabilized with vegetation, to ensure that the pond worked as an infiltration basin post-construction.

Pond 3. Overflow weir in distance is not yet finished – still requires stone riprap. (July 23, 2021)

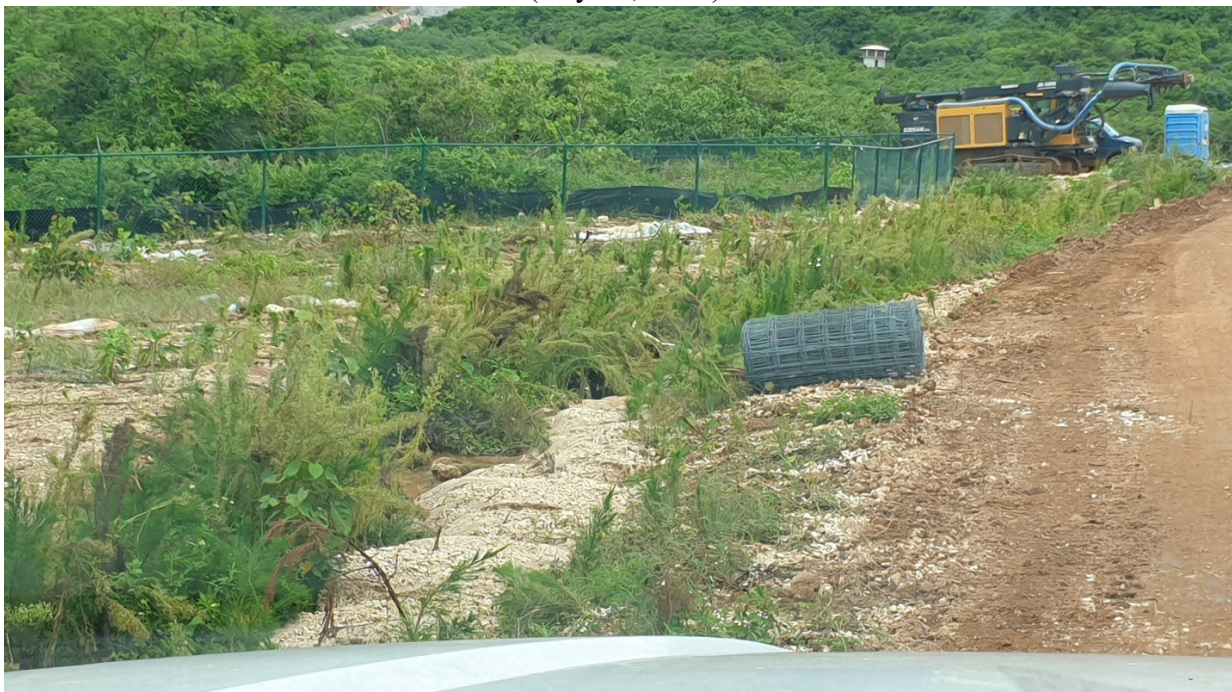
Perimeter berm which conveys runoff to Pond 3. Ironwood saplings and a large amount of accumulated sediment obstruct the flow. (July 23, 2021)

- I recommended that the ironwood saplings seen growing in the perimeter swales be removed as soon as possible, otherwise they would block the flow of water and potentially cause discharge of runoff off-site, instead of to the approved ponds.

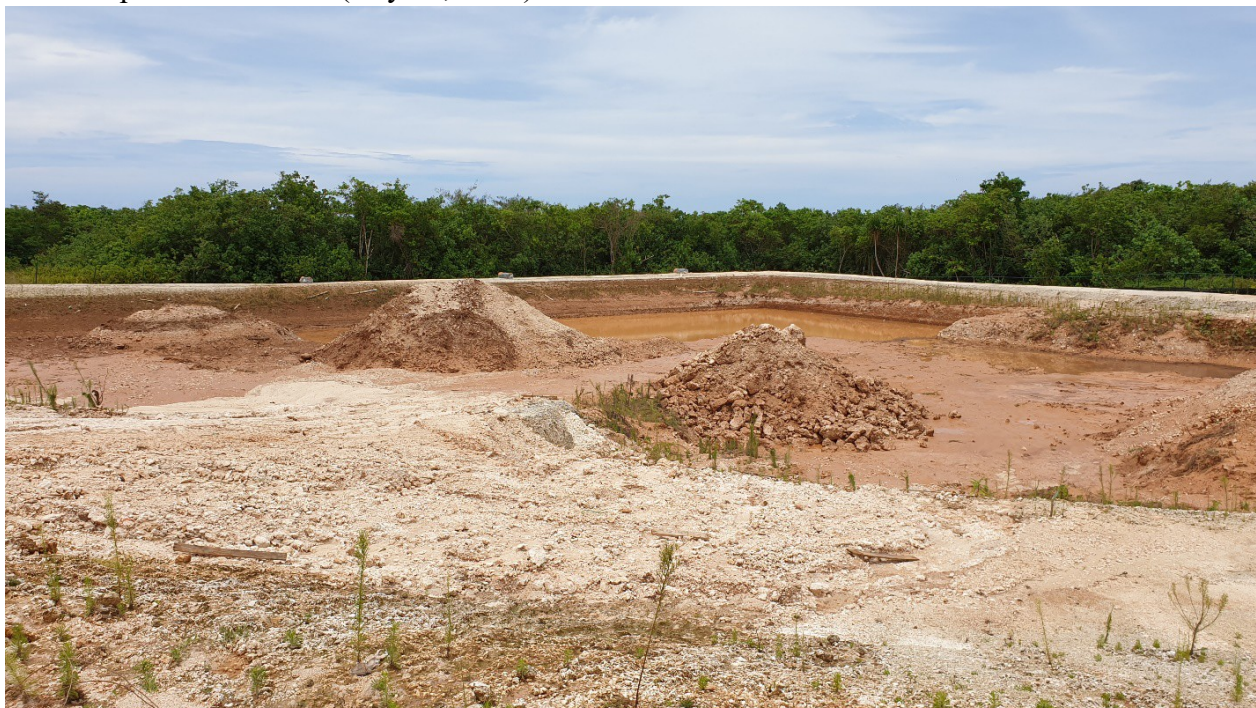
Pond 1. Note stockpiles of earth material, which reduce pond capacity. Also note high water mark from the previous storms. (July 23, 2021)

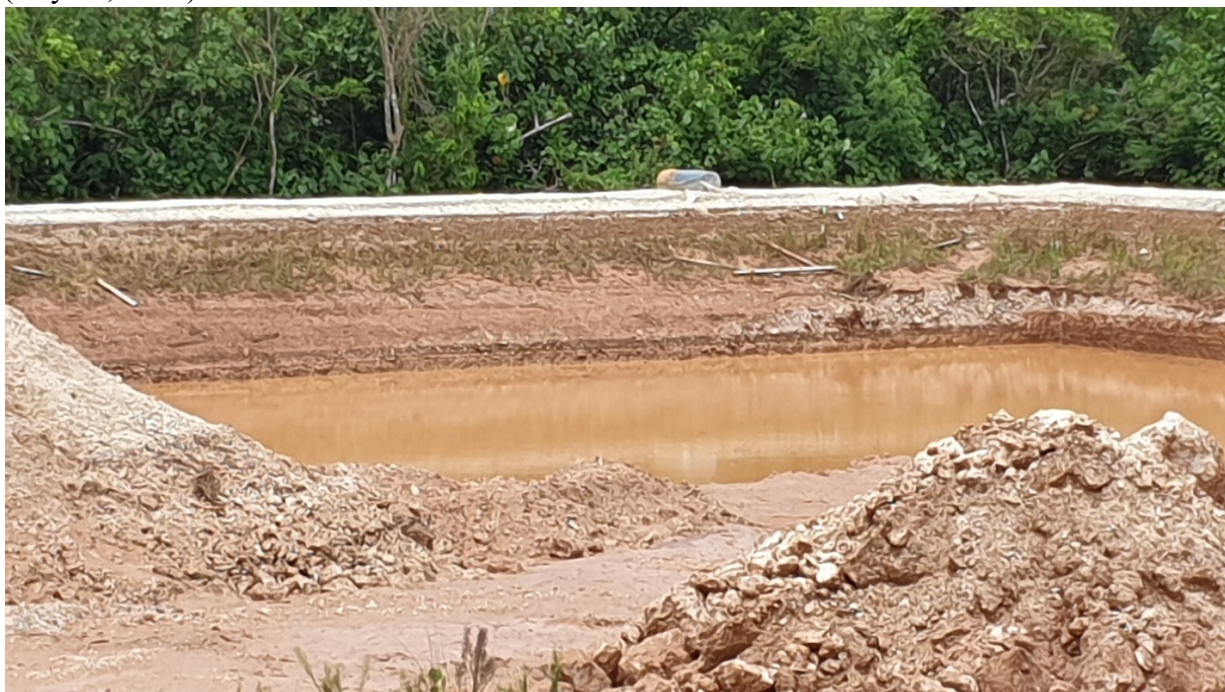
Close up of Pond 1 rim, showing high water mark indicating near-overtopping from prior storm. (July 23, 2021)

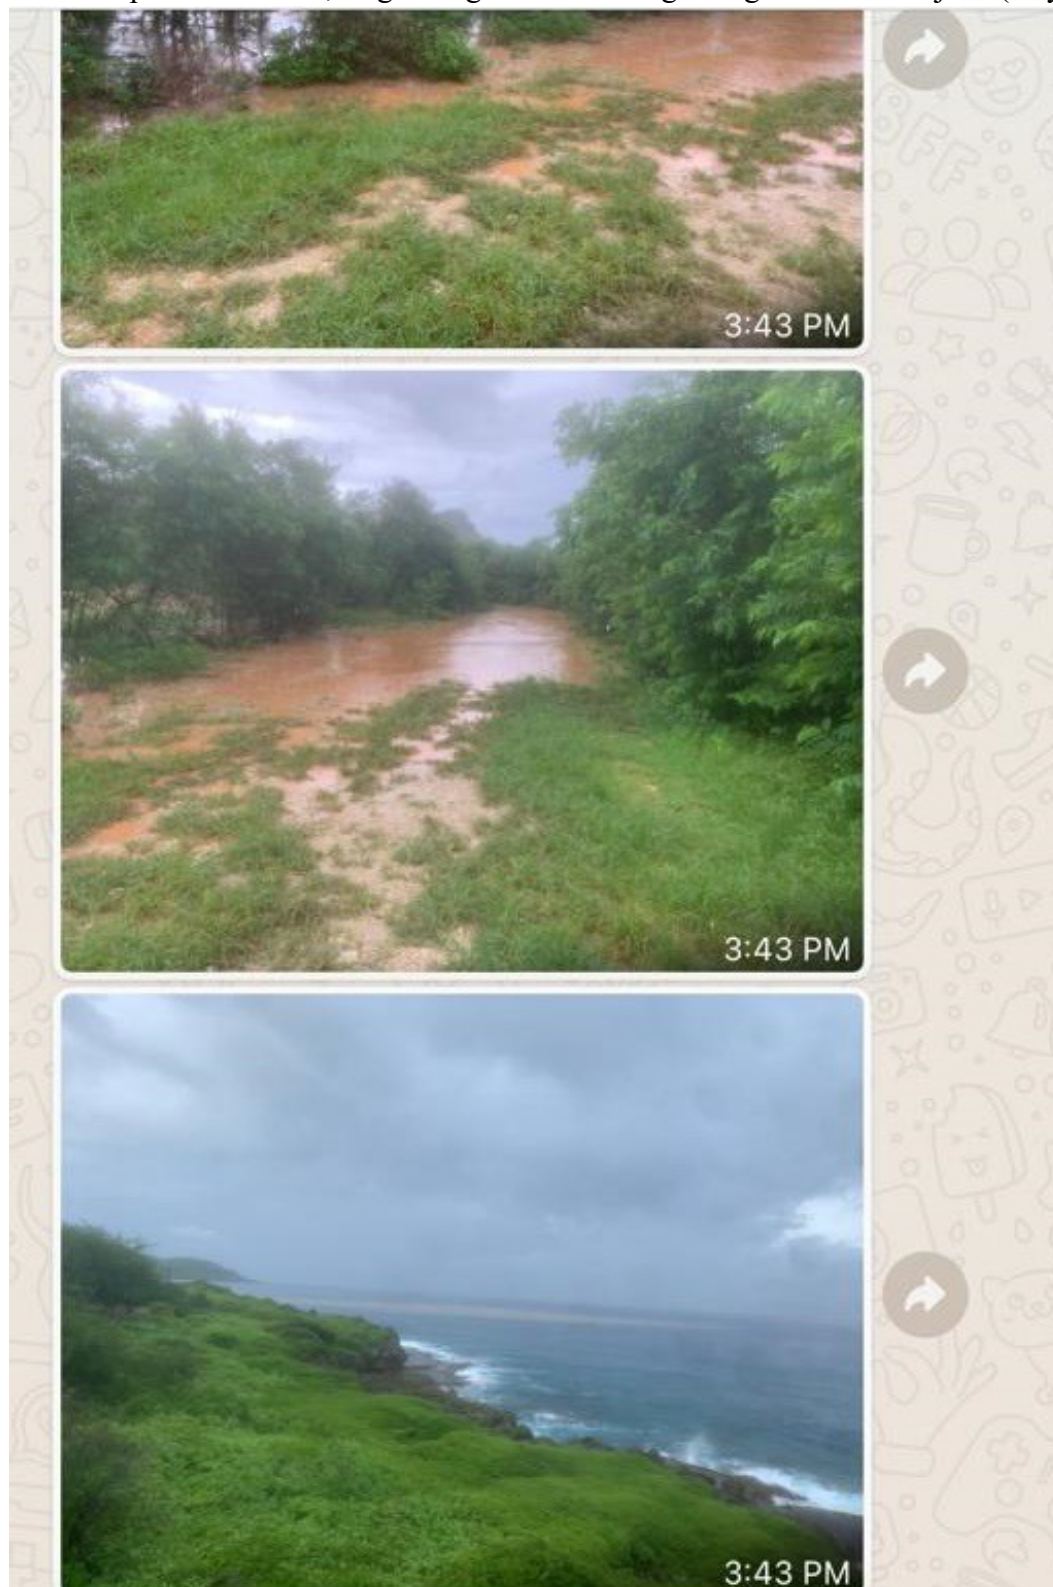
- There was evidence of discharge of runoff off-site, and also evidence submitted to us electronically that sediment-laden runoff had discharged to the ocean.

Images received over social media with original complaint. Bottom image purports to show sediment plume in ocean, originating from Samsung Mangilao Solar Project. (July 23, 2021)

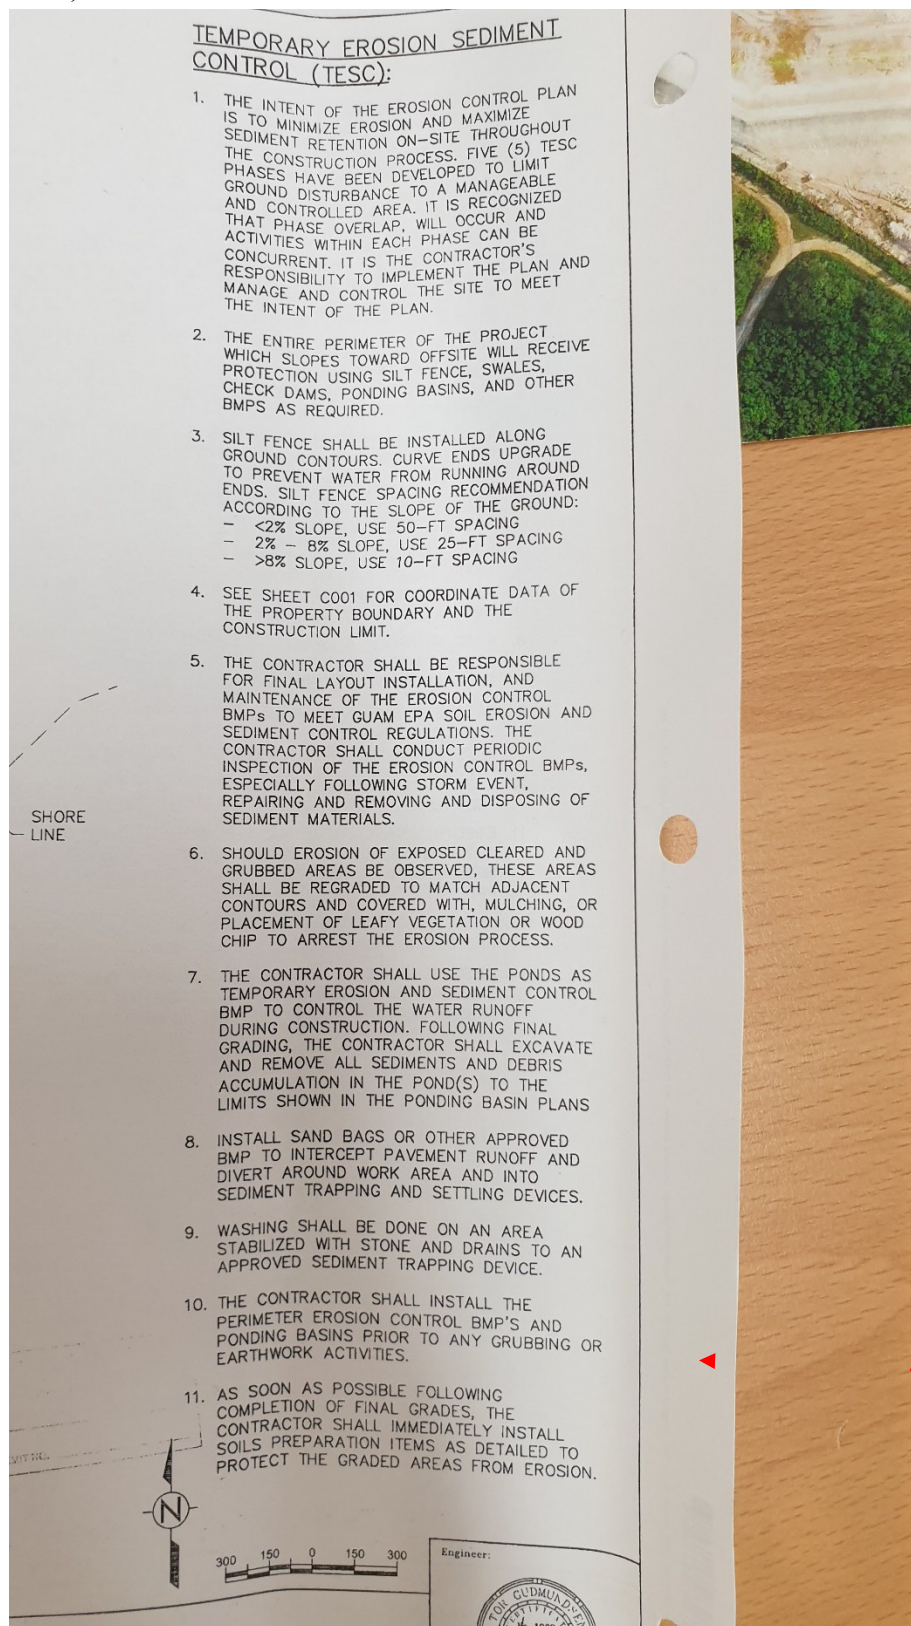
- Sedimentation basins (ponds) had not been constructed prior to the start of clearing and construction operations, and that this sequence of operations was required by Guam's regulations and was also spelled out in the approved plans that we reviewed at the office. I noted that Samsung is a very large company and should have known the proper sequence of installing E&SC measures.

Notes section from approved E&SC plan as obtained from Samsung during inspection. (July 23, 2021)

Note concerning required
sequence of construction
